**PREVENT**  
Waste Alliance

## Pilot to assess inspection methods at entry points and test practicability

<b>Project period:</b>	01.2021 - 10.2022
<b>Project partners:</b>	<a href="#">UNITAR SCYCLE</a> <a href="#">World Resources Forum</a> <a href="#">Vice Presidents Office Tanzania</a> <a href="#">National Environment Management Council (NEMC) - Tanzania</a> <a href="#">East African Communications Organisation (EACO)</a>
<b>Contact:</b>	Vanessa Forti <a href="mailto:vanessa.forti@unitar.org">vanessa.forti@unitar.org</a>  Otmar Deubzer <a href="mailto:otmar.deubzer@unitar.org">otmar.deubzer@unitar.org</a>
<b>More details:</b>	<a href="https://prevent-waste.net/en/tanzania/">https://prevent-waste.net/en/tanzania/</a>

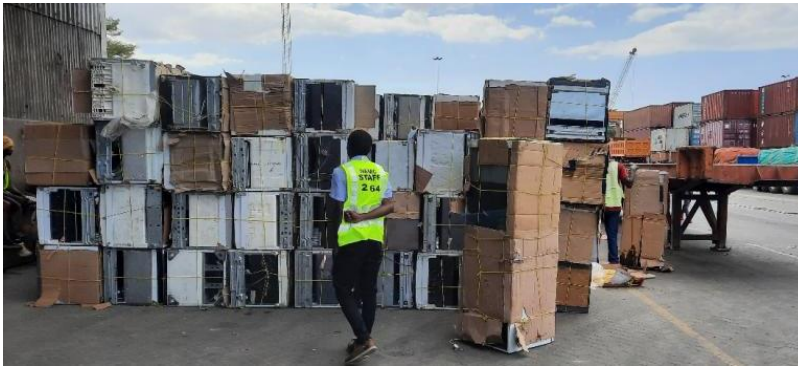
Figure 2 Example of the packaging of imported fridges

Inspectors checked if the imported goods were properly packed, as adequate packaging and storage is an important condition to meet when importing or exporting electric and electronic items (see Figure 2 for an example of the packaging of imported used fridges). In addition, the weight of each item was checked and noted (see Figure 3-left), keeping records of the weight of each item together with the number of units enables to assess the average weight of the imported goods and to characterize the imports. Further on, the inspectors collected information about the types of tests conducted and their result. Figure 3 shows an example of the inspections conducted at Azam Sealink ICD.

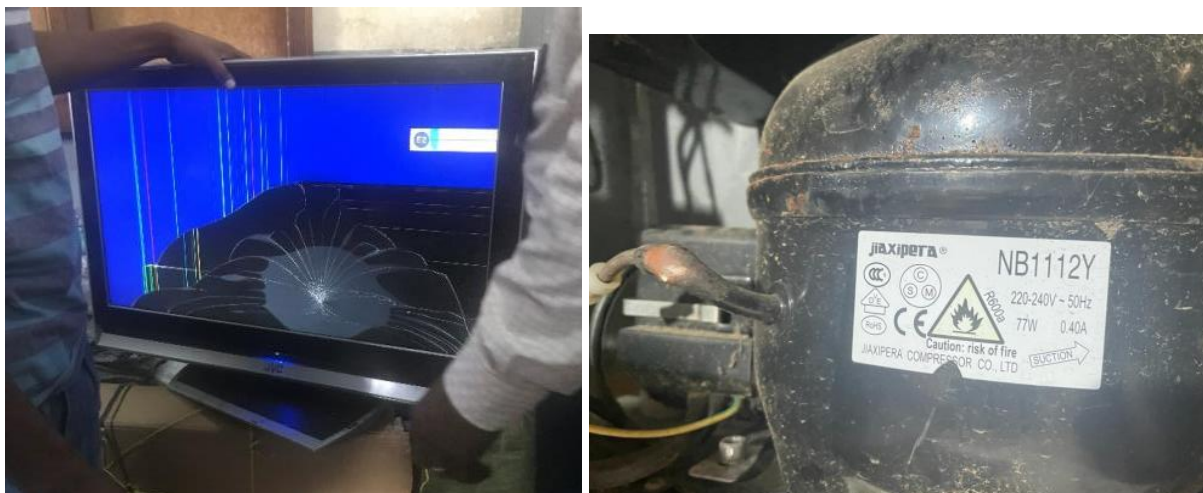
Figure 4 Screen regarded as e-waste after visual inspection (left), identification of refrigerant (right)

The inspection started with visual inspection which in some cases were sufficient to discriminate between e-waste and UEEE according to the check list and BCG, for example if an item was visibly damaged so that it must be regarded as e-waste (see Figure 4-left). The visual inspection was useful also to identify missing components that are essential for the proper functioning of the items (such as missing power cables, fridge doors etc.). Furthermore, the visual inspection enabled to identify types of refrigerant in used fridges to assess whether they are allowed to enter the country

according to the Environmental Management (Control of Ozone Depleting Substances and Hydrofluorocarbons) Regulations, 2022 (see Figure 4 right).

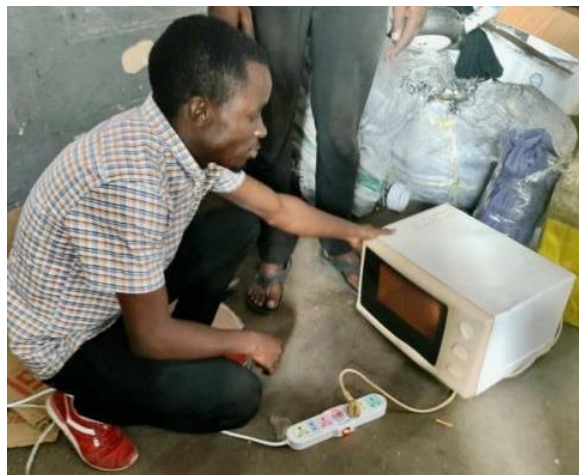
Figure 5 Functionality test of a microwave

Ultimately, if items had passed the visual inspection, some of them were subject to functionality checks to assess whether the appliance is to be considered e-waste or UEEE. The functionality tests consisted mainly of a simple switch on and off of the item and depending on the type of item, other functionalities were tested (see Figure 5).

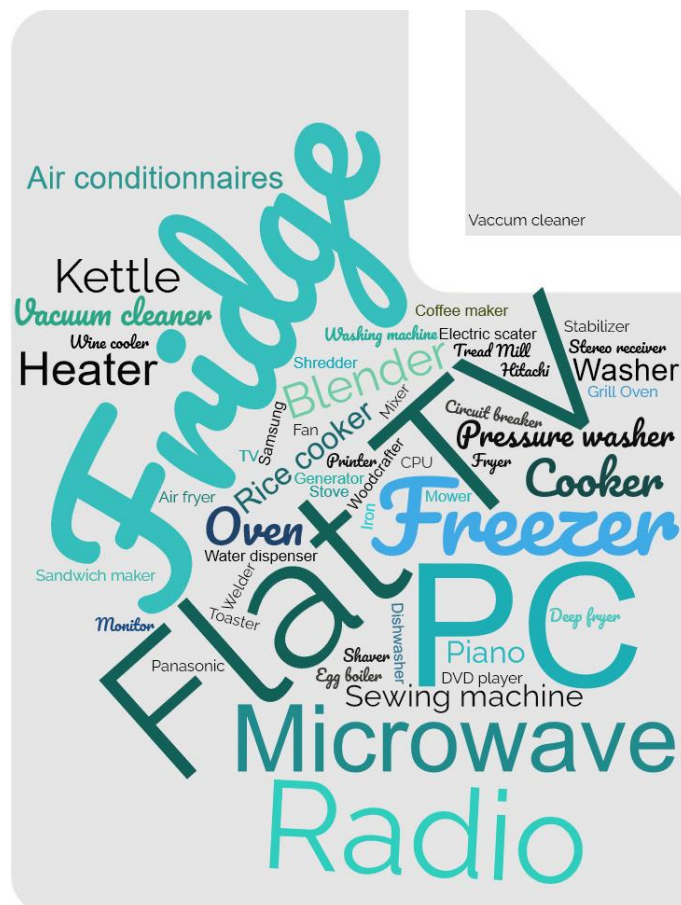
Figure 6 Type of products found during the pilot exercise

During the inspections a large variety of products were found. Figure 6 provides an overview of all type of items reported by the inspectors.

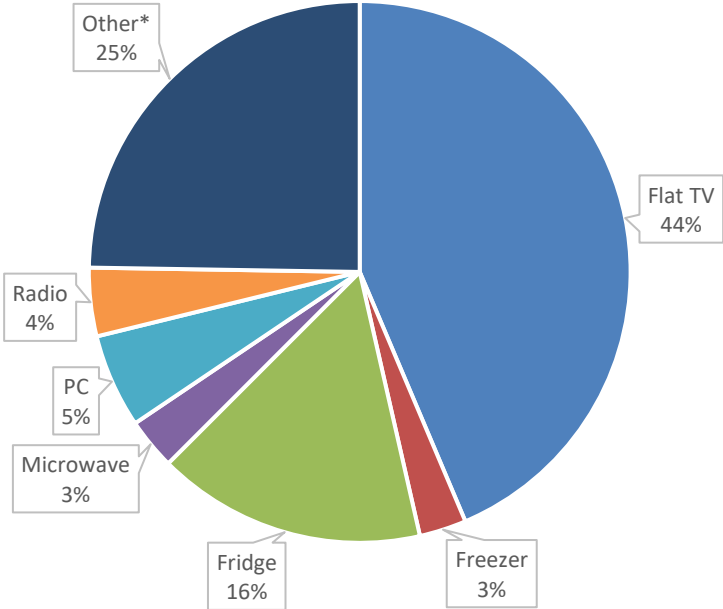
Figure 7 Share of products inspected and tested by type

The majority of the 392 items inspected and tested were flat TVs (44%) mainly originating from Zanzibar, followed by fridges (16%), personal computers (6%), radios (4%) and microwaves (3%). Another 25 % of the products tested (“Other” in the below graph) comprises a large variety of devices such as dispensers, sewing machines, egg boilers, mixers etc. **Error! Reference source not found.** illustrates the situation.

\* Other variety of products include blenders, heaters, oven, cookers, toasters, pianos, mixers, freezers, vacuum cleaners, washing machines, kettles, stoves etc.

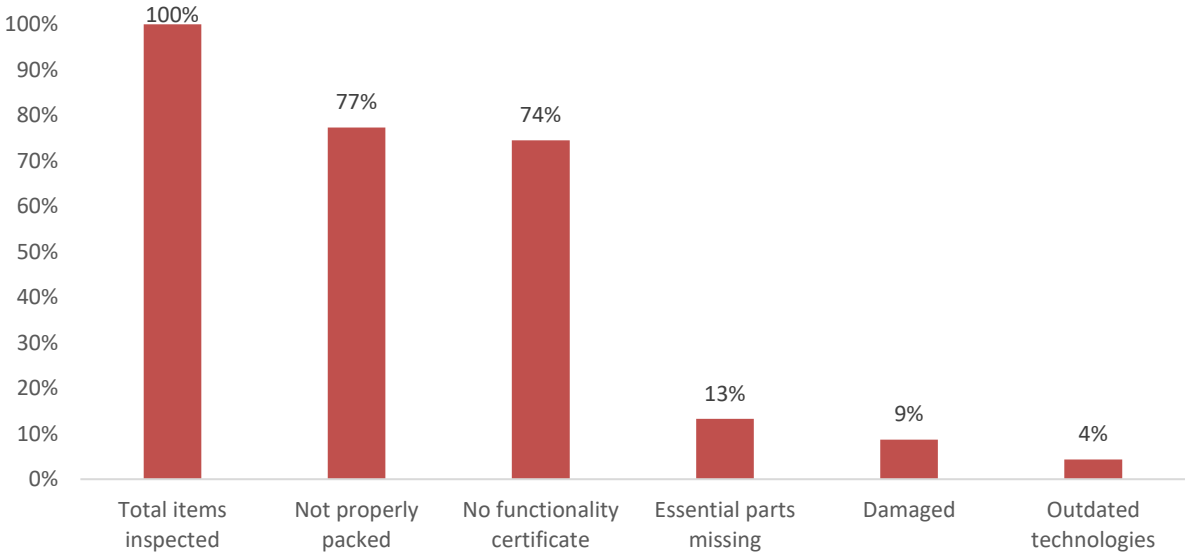
Figure 8 Results of the visual inspection (in percentage of the total items inspected: 392)

Visual inspections revealed that 303 items (77%) of the inspected and tested items (392) were not properly packaged, and 292 (74%) did not have a functionality certificate. 52 items (13%) were missing essential parts, 34 (9%) were visibly damaged and 17 (4%) were considered to have outdated technologies that may not meet the local market. Thus, according to the Basel Convention Technical Guidelines and the checklist developed during the project, those items were considered e-waste.
